Naremburn Park

Site Analysis - Ecology 2

Client: Willoughby Council
Sheet: 2/6 January 2008

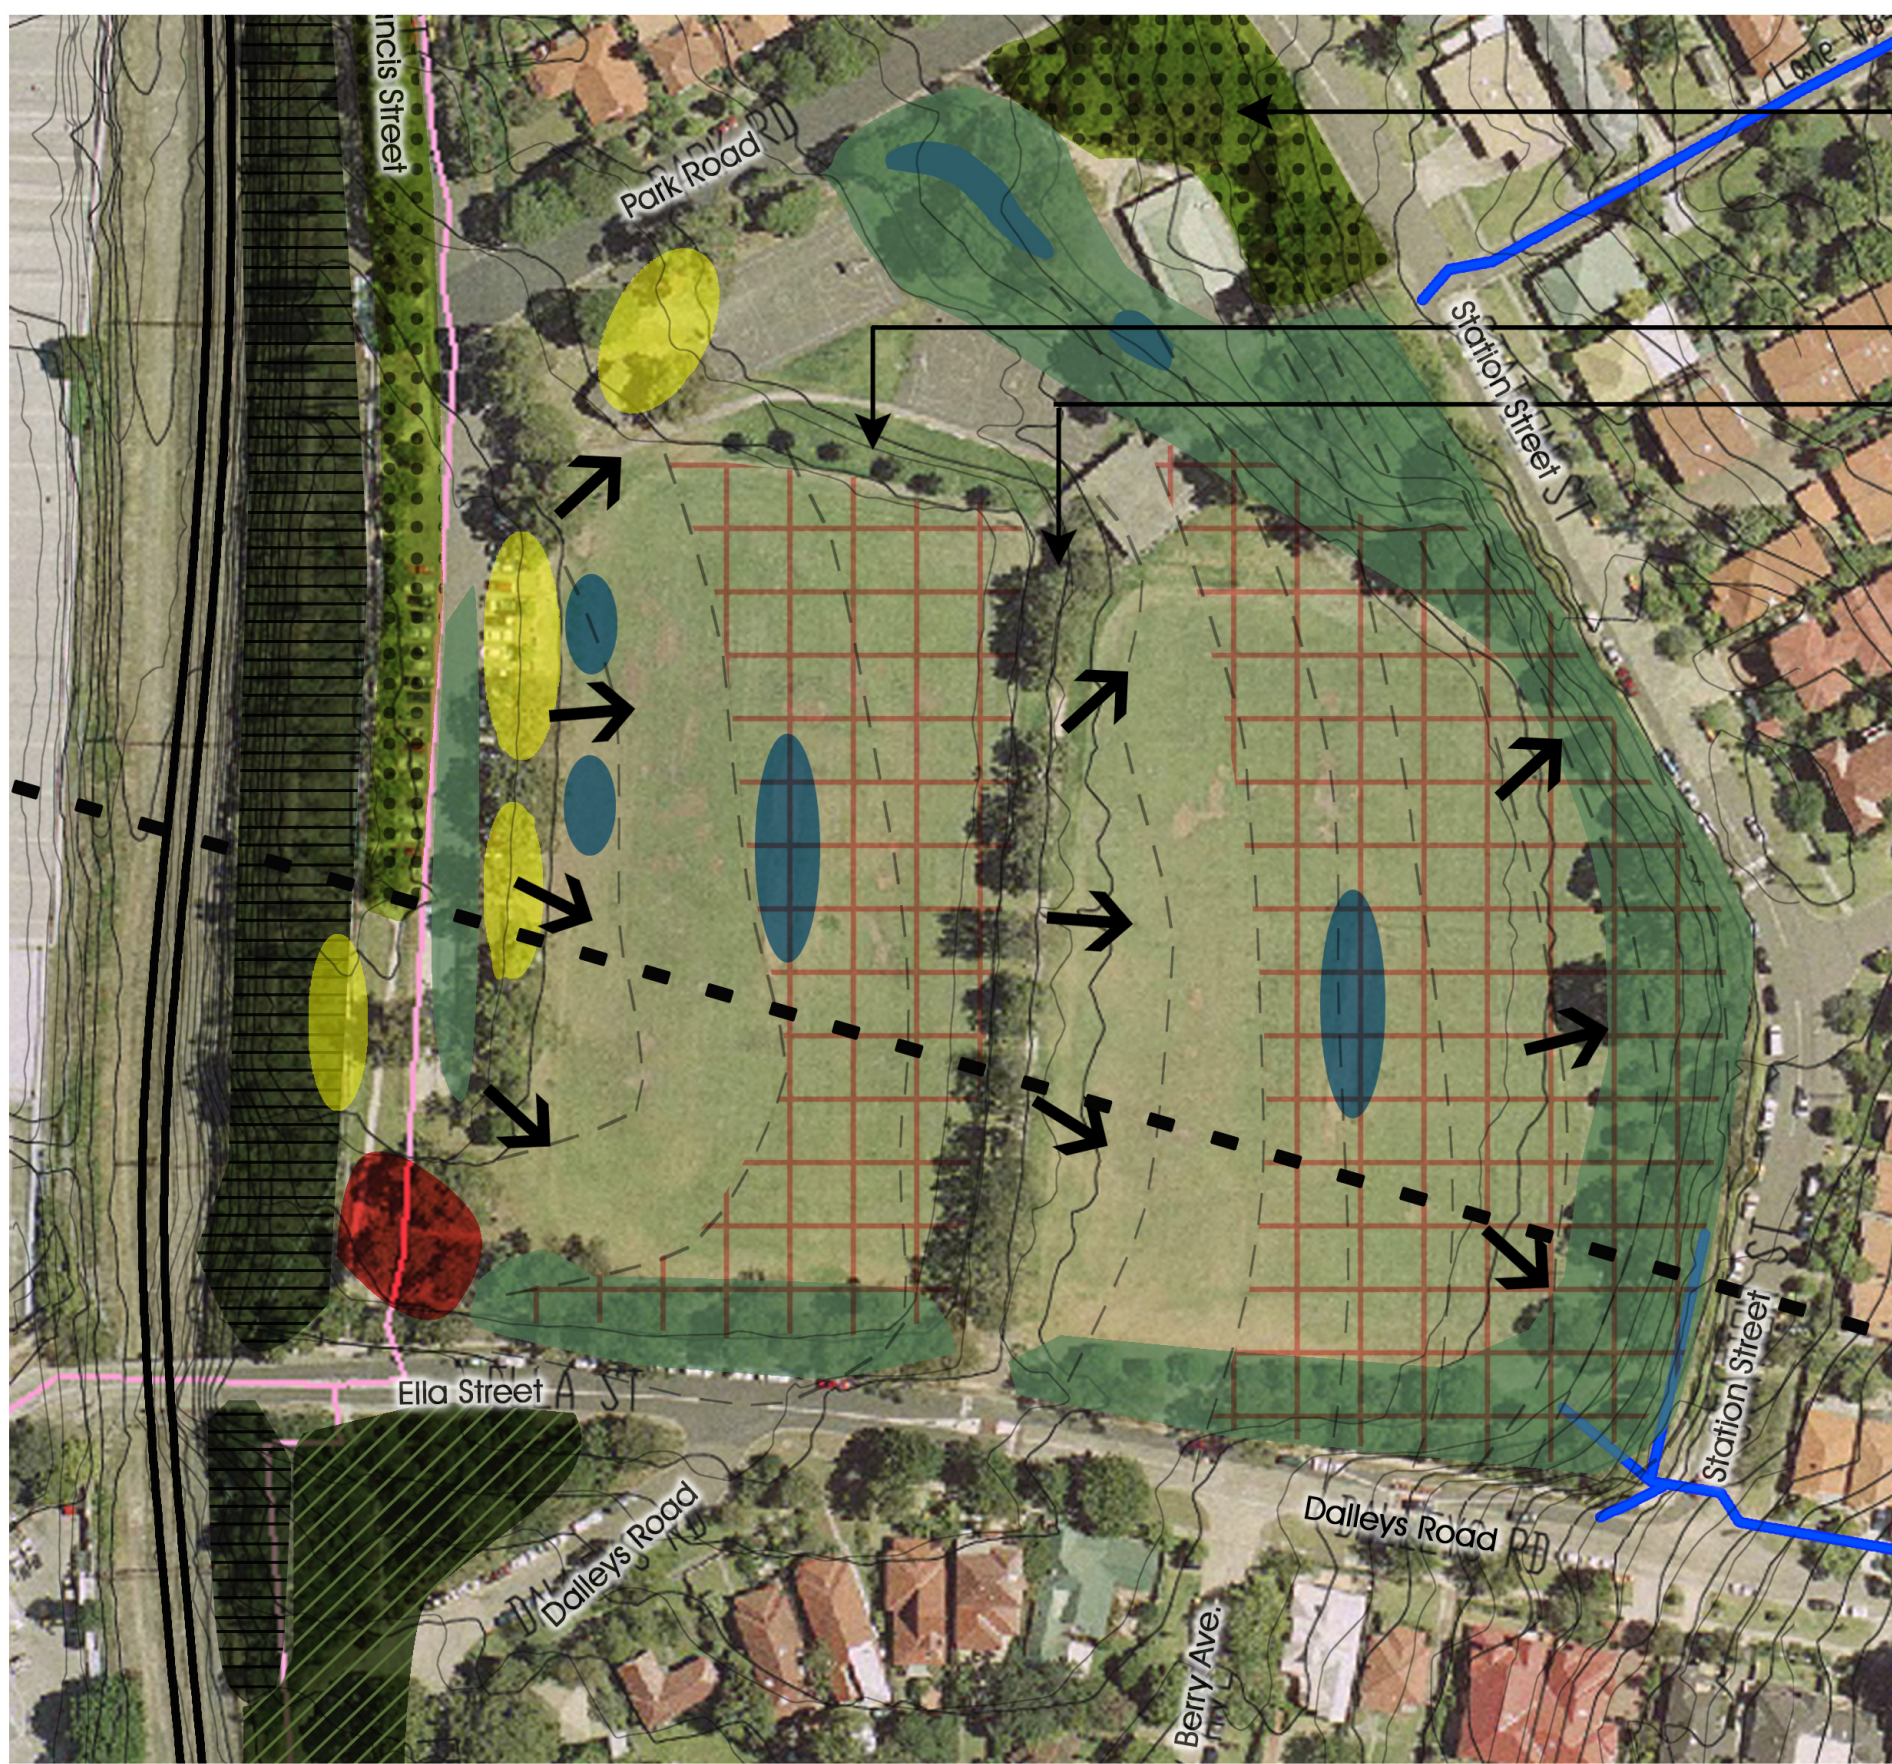
analysis

- Legend**
- Approximate original contours
 - Existing contours
 - Approximate fill zone
 - Overland flow
 - Drainage problems
 - Soil erosion
 - Degraded remnant vegetation
 - Mixed native and exotic planting
 - Native planting around park perimeter
 - Bush walk link to St Leonards Station
 - Recent dumped fill. Trees show signs of stress
 - Sewer main
 - Stormwater (underground) flow

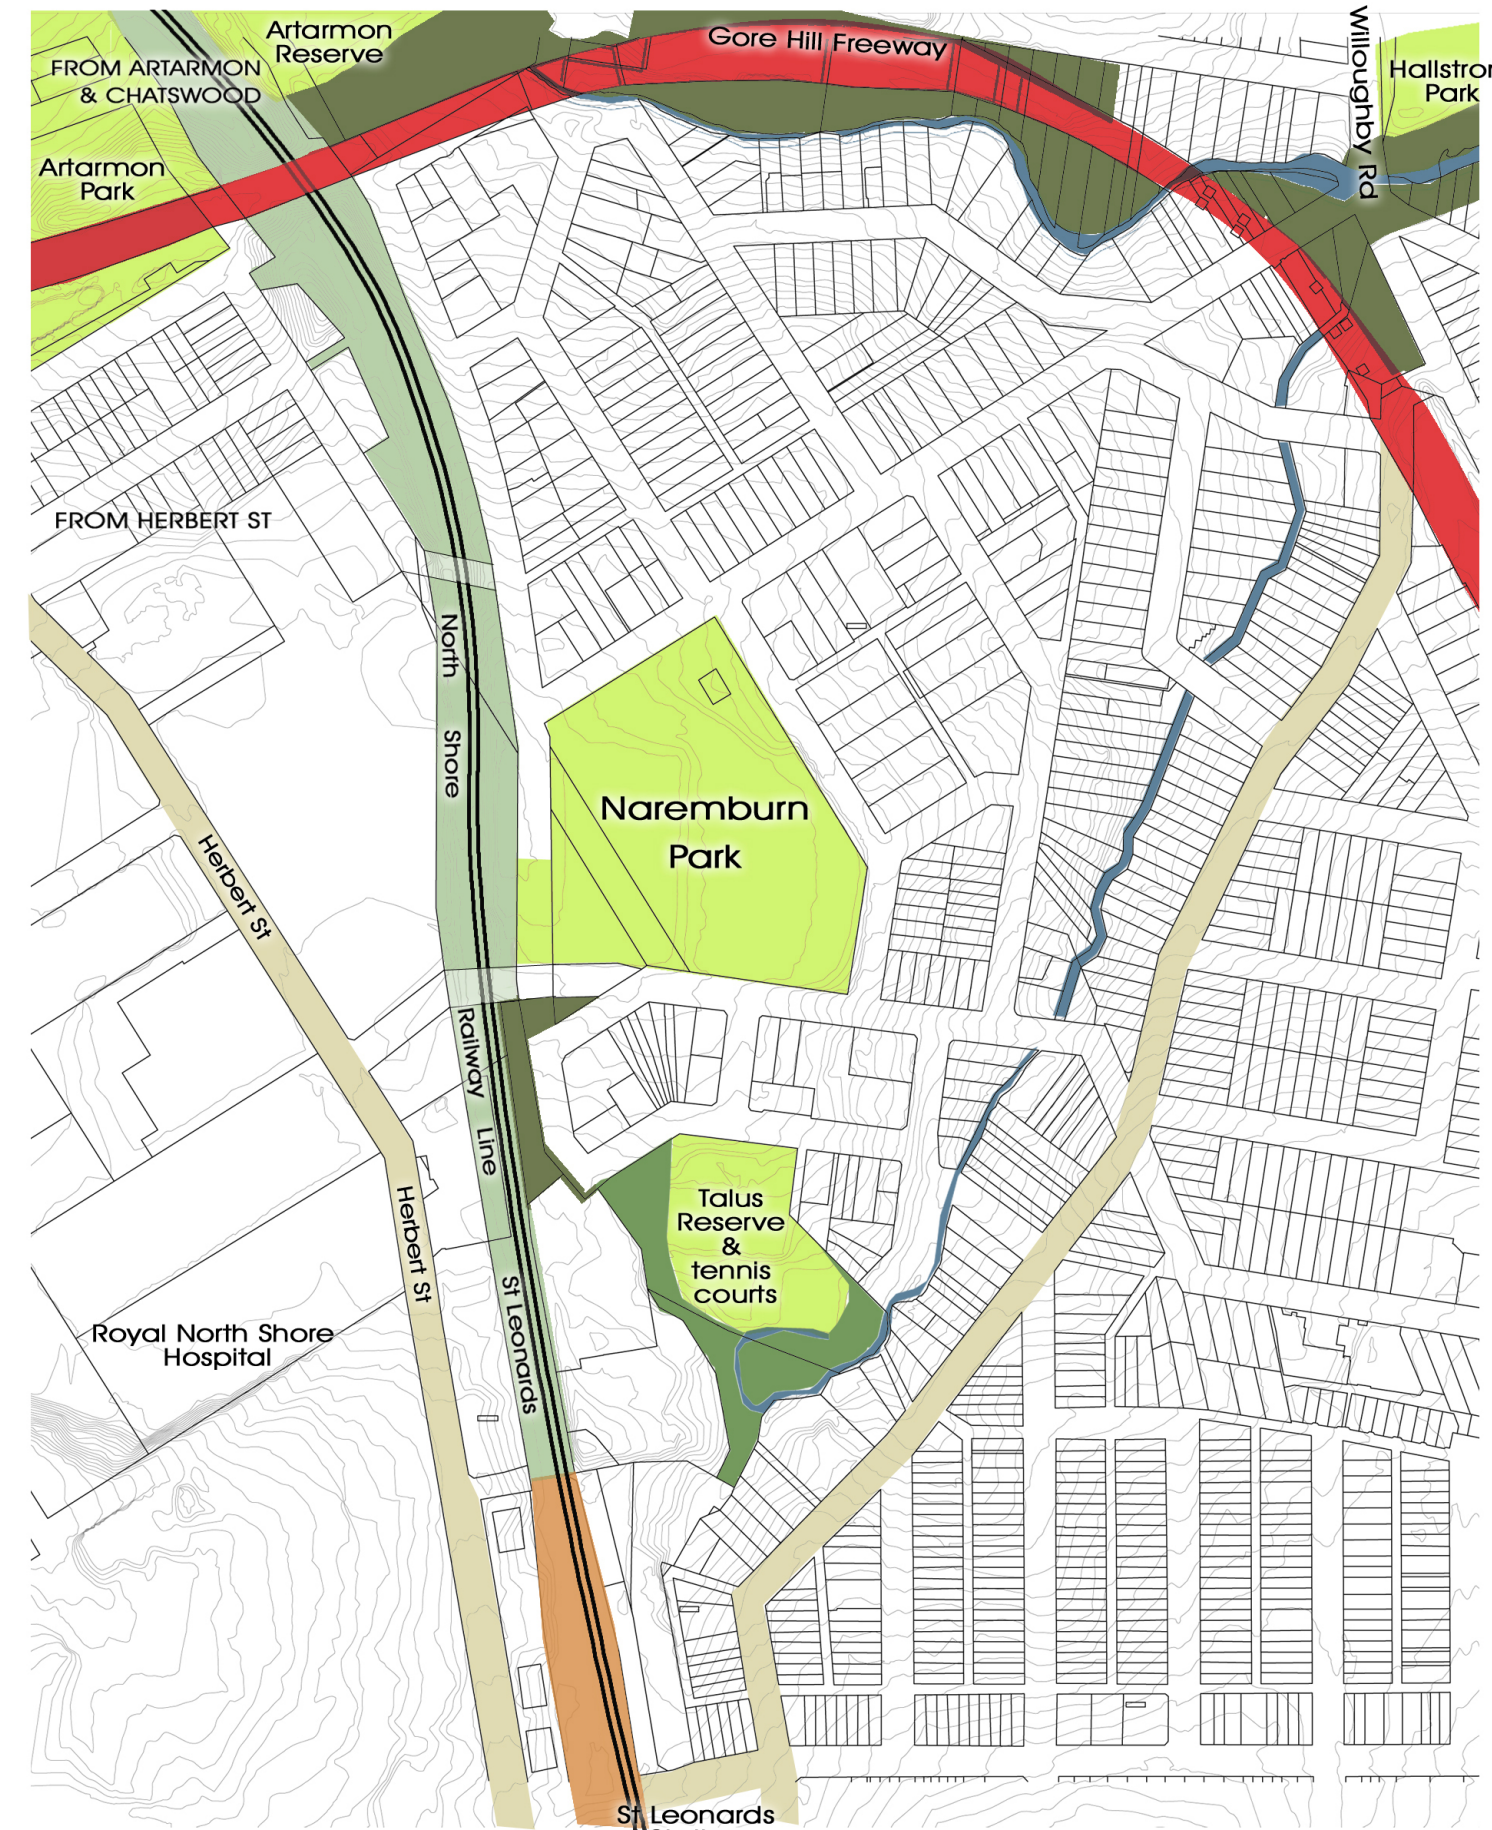
links-vegetation

- Legend**
- Railway line
 - Major highway
 - Sports grounds & parks
 - Barrier to corridor
 - Railway corridor with remnant indigenous plants
 - Council "bushland" fabrication
 - Remnant vegetation
 - Water course
