Willoughby City Council 20 Year Asset Management Plans

2013/2014

Document Control		Willoughby City Council – Bridges Asset management Plan			
Rev No Date		Revision Details	Author	Approver	
1	12/01/2014	First draft based on FY2012/2013 figures	Agnes Tan / Paul Gomez	David Sung

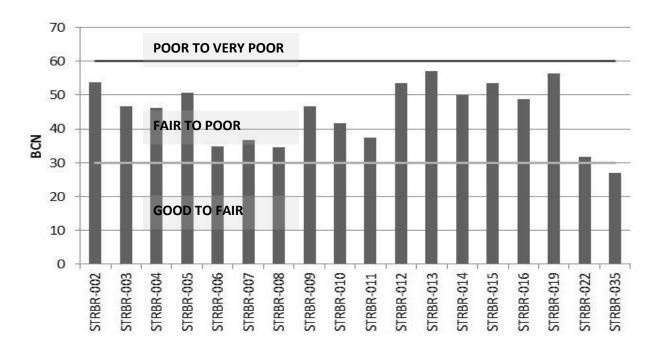
Figure 5.2 Distribution of physical condition of major bridges as at 30 June 2013

As shown above, the majority of structures classified as major bridges are in a fair condition, and none in poor condition. Previous generations of AM Plan showed STRBR-002 (Concrete bridge at Lower Gibbes St) and STRBR-019 (jetty structure in Northbridge Baths) as the two worst structures. However, this year, some of the timber bridges in the reserves (STRBR-012, STRBR-013, STRBR-015) have deteriorated and are now reaching closer to the poor to very poor mark. This is because the timber structures have shorter life and therefore degrade more quickly.

Condition assessment of major bridges is based on the *VicRoads 2004 Bridge Inspection Manual*. As the major bridges are complex assets, a condition rating has been assigned for each component of the bridge. Following the method in the manual, individual component ratings are then used to calculate a Bridge Condition Number (BCN) for each bridge. Table 5.2 summarises the BCN with respect to the actual bridge condition.

Level 2 inspections of all major bridges and culverts is due to be carried out in 2013/2014 financial year. This inspection may result in the condition rating above, depending on the actual degradation rate of the bridge components. Results from the inspection will also enable Council to check the validity of some of the assumptions that have had to be made, including the estimated useful life of the timber bridges.

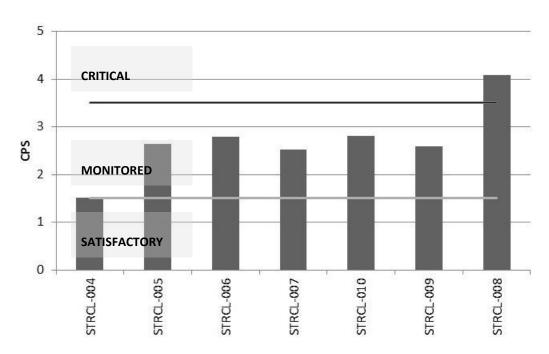
Figure 5.3 Distribution of physical condition of major culverts as at 30 June 2013

The one culvert that was identified as being in the 'Critical' zone is a sandstone arch culvert at The Bulwark. Several rehabilitation solutions were considered and during the 2012/2013 financial year, Council constructed suspended slabs over the culvert to arrest the deterioration caused by traffic loading.

The condition distribution of Council's major culverts as at 30 June 2013 is shown in the figure below. For more details on each individual structure, refer to section 0. Note that only 7 out of the 8 major culverts have a CPS assigned; the one remaining major culvert is located below ground and has consequently been inspected using CCTV, and assessed on the 0-5 scale, and was rated as Condition 2.5.

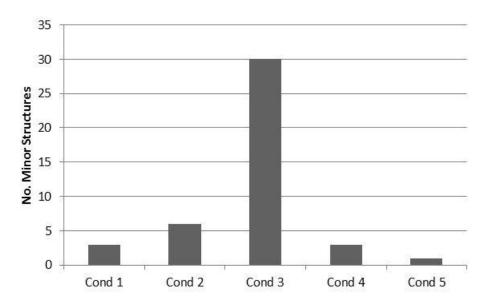
Figure 5.4 Condition distribution of minor structures

As shown in the figure above, the majority of minor structures are in condition 3, which reflects a condition rating of 'moderate'. During the first round of inspection, these structures were mostly in condition 2. Most minor structures are small timber structures in parks and reserves, and have been assumed to have short useful life, e.g. 10 years for timber bridges. During the next round of inspection, comparison will be made with last inspection's data to validate the rate of deterioration and, if necessary, refine the assumptions.

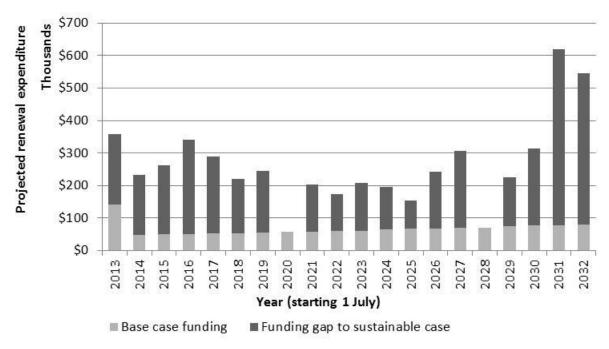
Figure 5.5 Projected renewal expenditure under the base and sustainable cases.

For the assets covered by this Plan, the cost of renewals is based on the replacement cost of the assets. In some cases, actual works may be higher if, for example, the component to be repaired cannot be accessed without also replacing another component. The difference between current funding levels (base case) and projected required renewal funding (sustainable case) is shown in Figure 5.5.

For bridge assets this graph is the same as Figure 5.5, as 100% of the bridge funding plan has been allocated to renewal only.

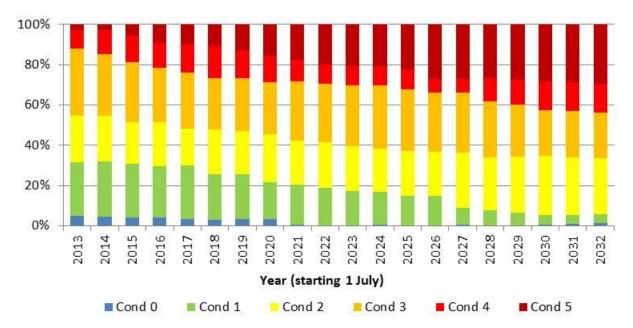
Figure 5.6 Projected asset average condition and distribution under the base case funding

Where funding shortages mean that renewals cannot be completed in a timely fashion, the asset pool is expected to decline in condition overall. Figure 5.6 shows the expected degradation in the average condition of the asset pool, as well as the distribution of condition by replacement value. Due to the higher risk they carry, a badly deteriorated bridge may need to have its load limit reduced or even closed to traffic for safety reasons.

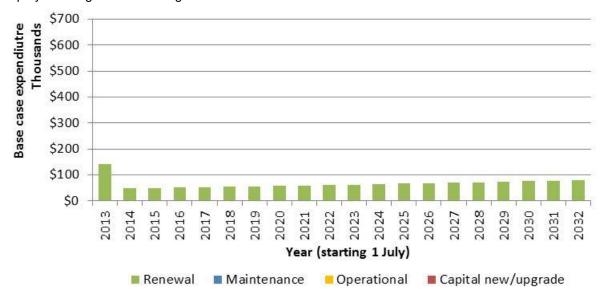
Figure 5.7 Projected 20 year asset expenditure under the base case

As shown in the two figures above, the base case expenditure falls significantly short of the sustainable case. Base case funding for renewal works mean that Council is already facing a shortage of funds for the assets covered by this Plan. Over the 20 year period, this shortage amounts to a total of \$3.9M or an average of \$196,000 per year.
