Beauchamp Park, Chatswood ISSUES REPORT

for Willoughby City Council

BioDesign & Associates Pty Ltd
August, 2007

BEAUCHAMP PARK ISSUES REPORT

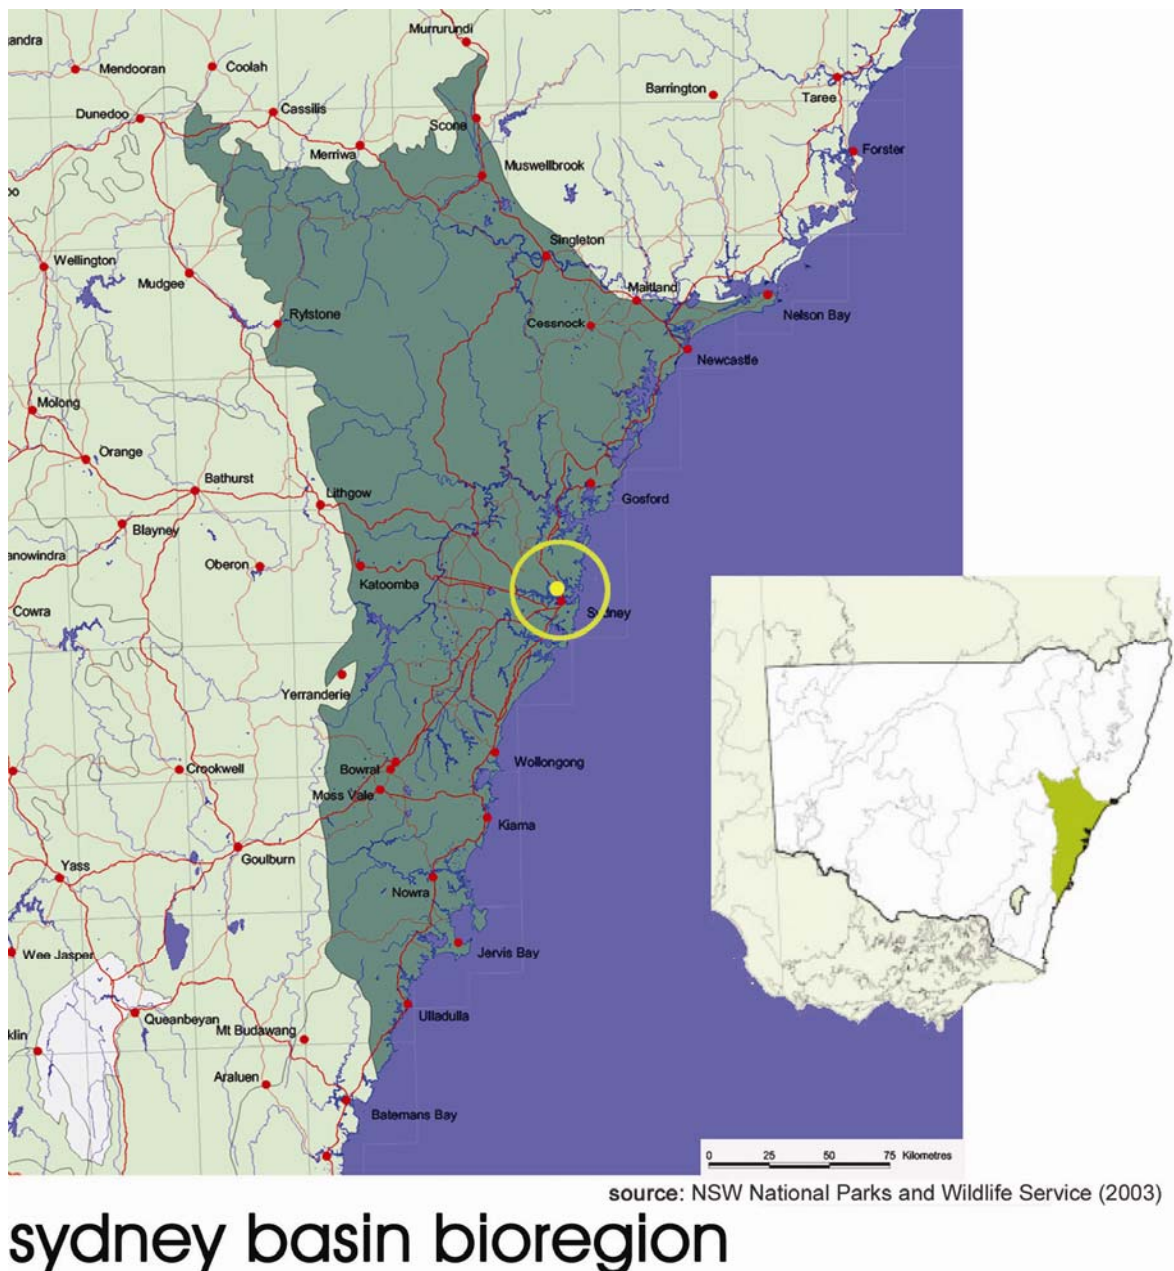
Figure 7: Beauchamp Park (circled) is located within the Sydney Bioregion.

Beauchamp Park is located within the Sydney Basin Bioregion (Figure 7) which has a temperate climate with significant variations in climatic elements (Bureau of Meteorology, 1991). The Willoughby Municipality experiences a subtropical coastal climate with hot humid summers and mild winters (Willoughby Fact Sheet No. 21, 2003).

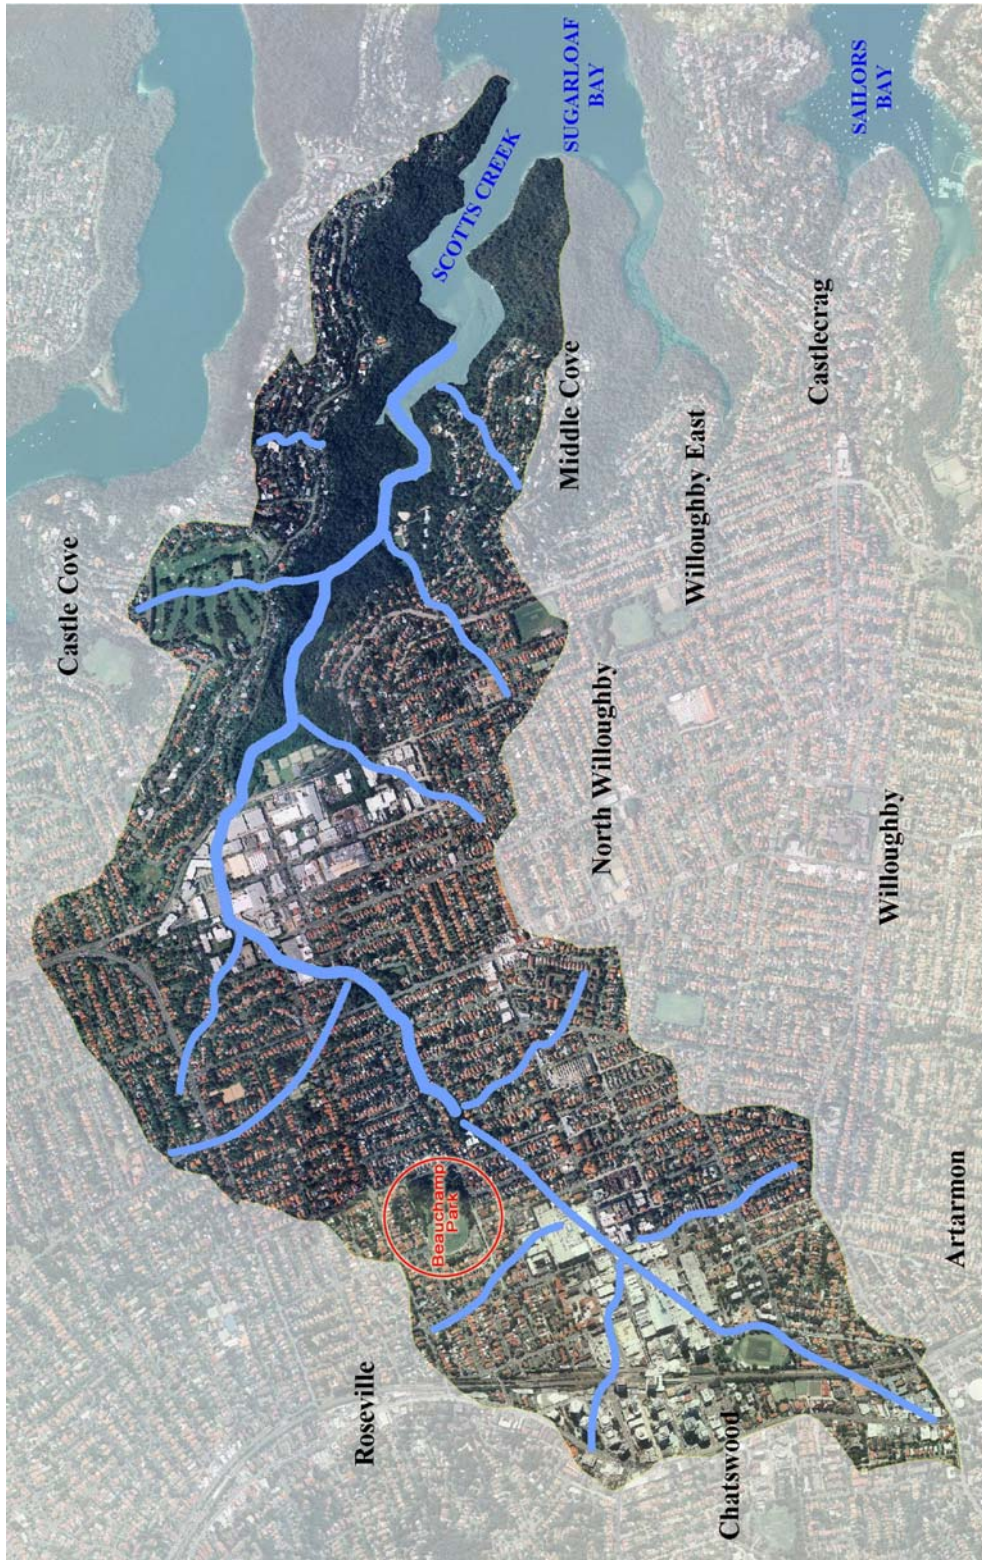
Figure 9: Map of the Sydney catchment in which Willoughby, including Scotts Creek sub-catchment, is situated.

Willoughby LGA is located within the Sydney Harbour catchment portion of the Sydney catchment (Figure 9) and contains several small sub-catchments. Beauchamp Park is situated in the upper part of the Scotts Creek sub-catchment (Figure 10). The park drains to the corner of Nicholson and Darling Streets, east behind the houses along Nicholson Street in a concrete lined channel to Muston Park, then along Scotts Creek to Castle Cove, Sugarloaf Bay and finally to Middle Harbour, the northern arm of Sydney Harbour (Figure 11).

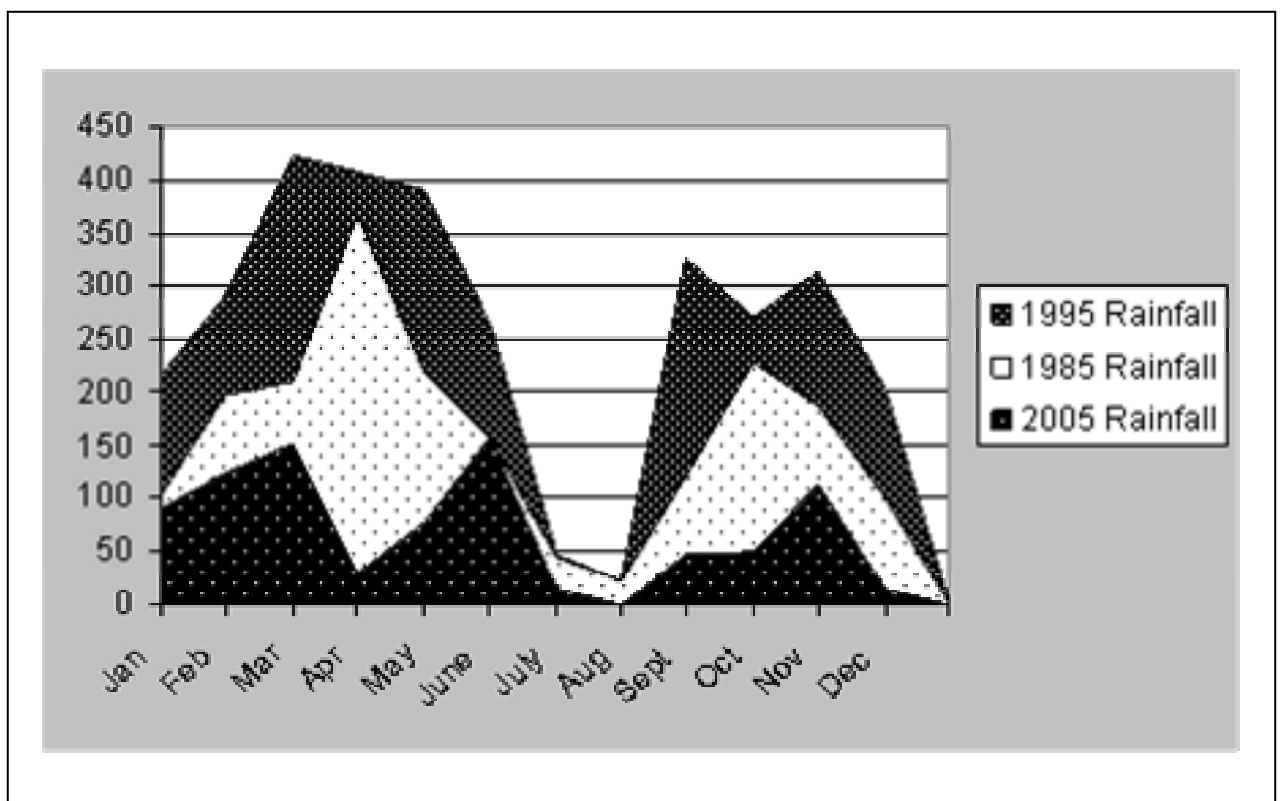
Total rainfall in Willoughby (data taken from Northbridge Rain Gauge) for 2005 was 873.5mm, a 30% decrease from the average annual rainfall of 1190mm taken over 20 years. Comparisons of rainfall in Northbridge in 1985, 1995 and 2005 show not only very variable rainfall in the last 20 years but a changing pattern (see chart below).

Comparative rainfall data for Northbridge from 1985-2005 (Source: chart prepared by Sue Stanford, Environmental Engineer, Willoughby City Council).
