Willoughby City Council Water Quality Monitoring Report Spring 2022 - Autumn 2023

Report version: Spring 2022 - Autumn 2023

Report Name: Willoughby City Council Water Quality Monitoring Report

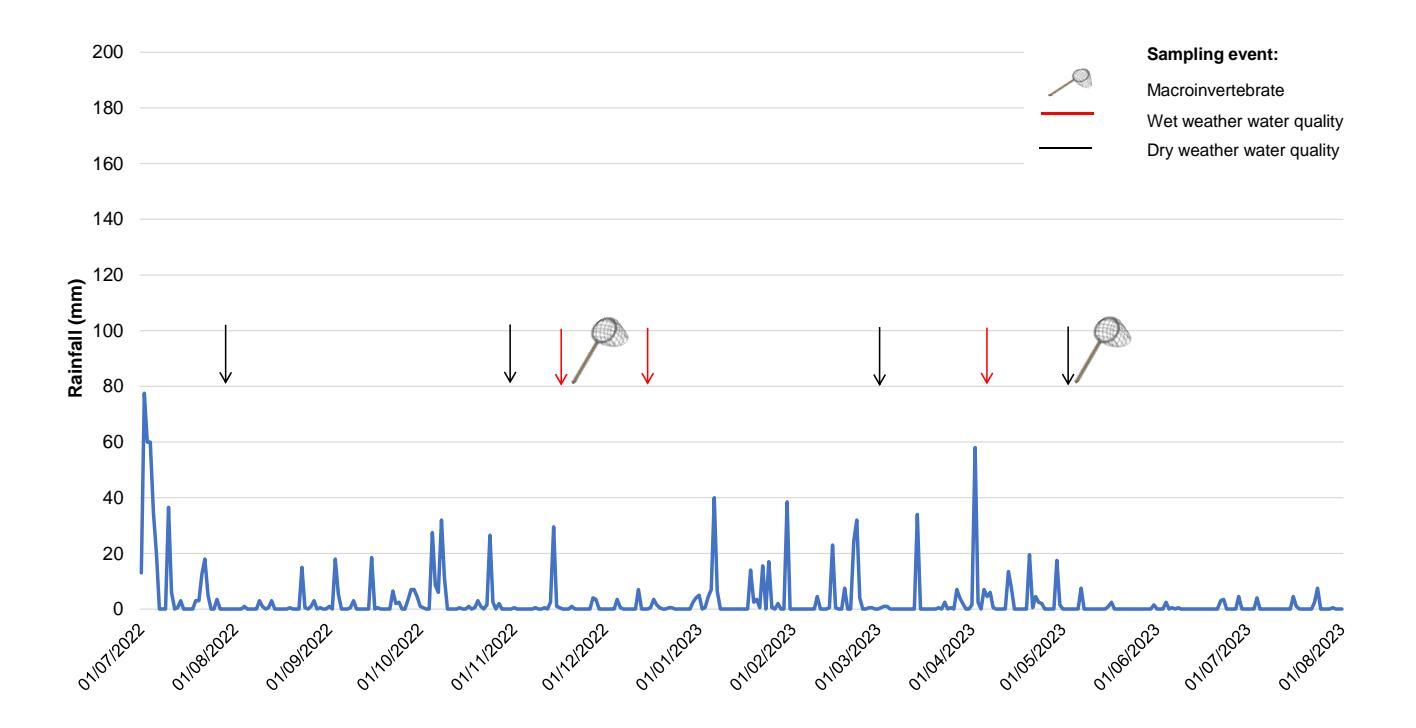
Figure 7 Rainfall and sampling events for Spring 2022 and Autumn 2023

Daily rainfall for the sampling period is presented below (Figure 7). Rainfall was generally low and sporadic throughout the sampling period. The highest daily rainfall for the period was 77.5 mm on 2 July 2022. Other daily rainfall events over 50 mm were recorded on 3 July 2022 (60.0 mm), 4 July 2022 (60 mm), and 2 April 2023 (58.0 mm). The cumulative rainfall between 1 July 2022 and 1 August 2023 was 1,162 mm.

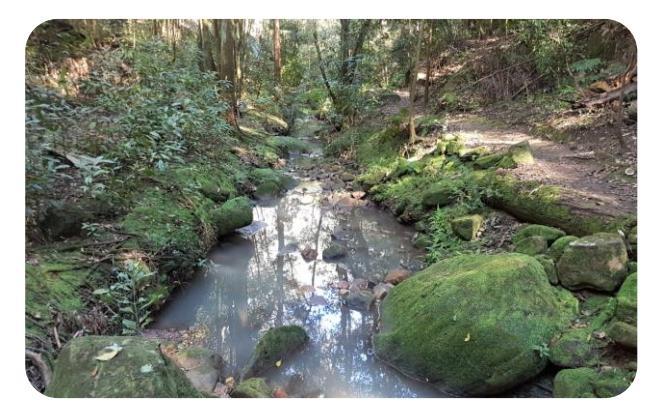
Figure 8 Swaines Creek

WCC_SW1 is the sole site on Swaines Creek, located midstream within the catchment. It is located in a narrow section of creek and has a moderate amount of native riparian vegetation. During dry weather, the site experiences low to moderate flows and its substrate comprises mainly bedrock, boulders, and cobbles, with moderate algal cover (Figure 8). A sewer overflow point is present immediately upstream of the sampling area.

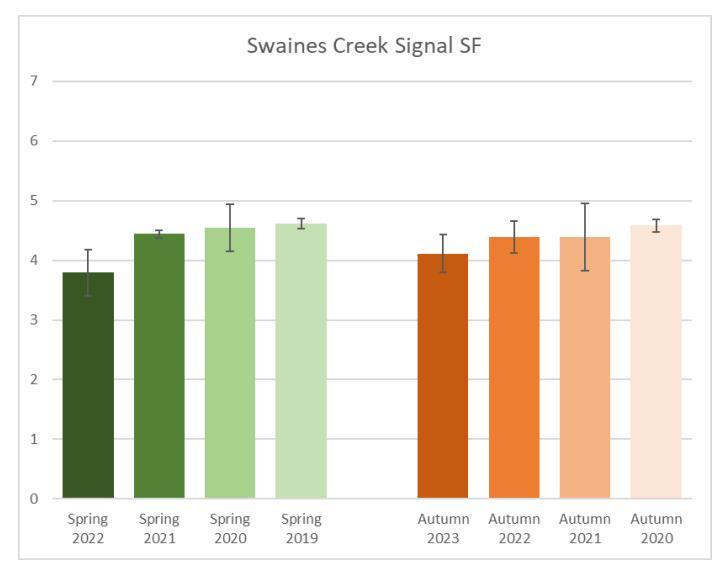
Figure 9 SIGNAL SF results for Swaines Creek

The SIGNAL SF score for Spring 2022 was lower than previous years and was the lowest SIGNAL SF score for the current reporting period. The SIGNAL SF score for Autumn 2023 was within the range of historical results.

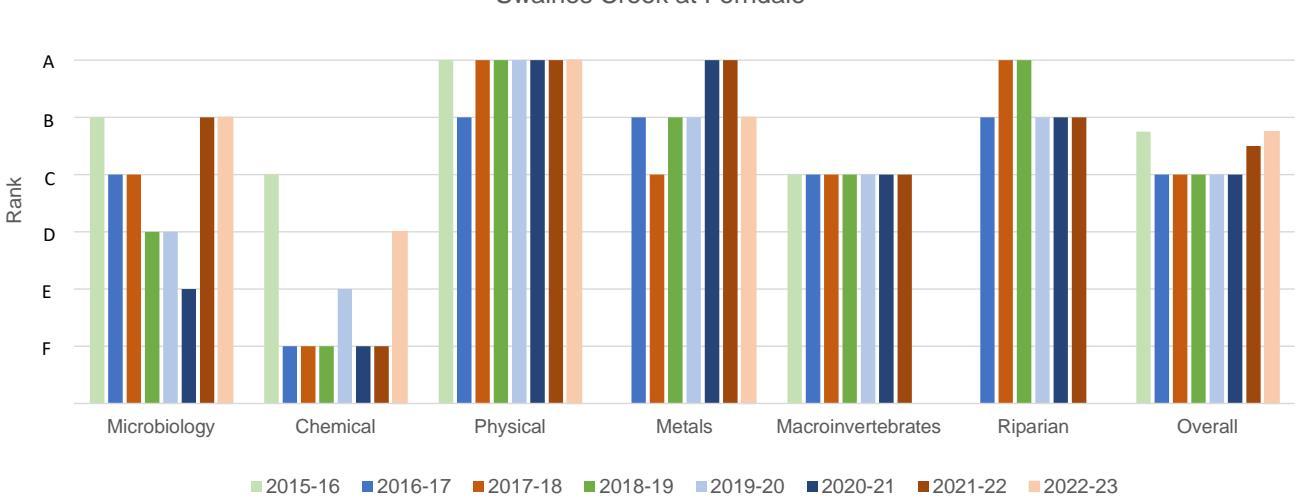
Figure 11 Summary of Swaines Creek scorecard rankings

The chemical ranking improved to a D in 2022-23 compared to F in 2021-22, while the metals ranking fell from A in 2021-22 to B in 2022-23. This was reflected by a slight increase in the overall scorecard ranking (Figure 11).

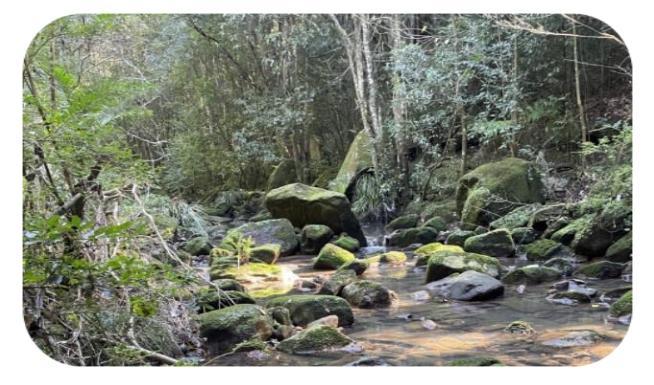
Figure 12 Flat Rock Creek at Flat Rock Gully

WCC_FR1 is on Flat Rock Creek, located in the lower section of the catchment. This site lies at the base of a relatively steep catchment and is characterised by several deep pools which exhibit low to moderate flow during dry weather. The substrate consists primarily of bedrock and boulders, and the riparian vegetation of both native and exotic species (Figure 12).

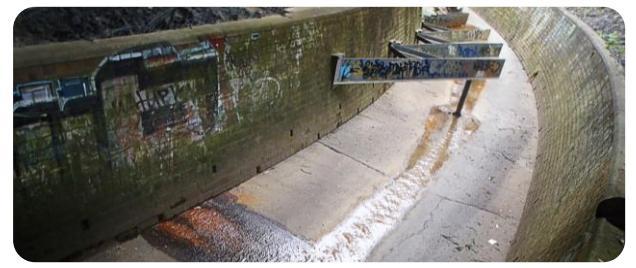
Figure 13 Water quality sampling point for WCC-FR2

WCC-FR2 is sampled on Flat Rock Creek, upstream from WCC_FR1, located midstream within the catchment. WCC_FR2 is situated upstream of a gross pollutant trap located underneath the Gore Hill Freeway. This section of creek consists of a fully concreted canal system (Figure 13) with low flows during dry weather. Domestic rubbish and algae were recorded at this site.

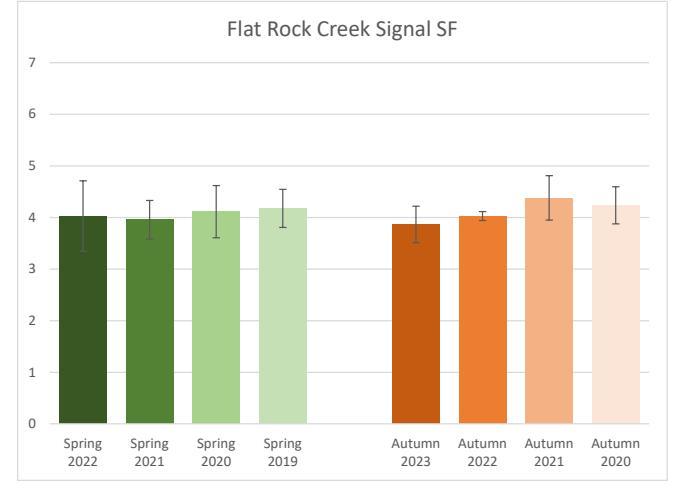
Figure 14 Flat Rock Creek SIGNAL SF results

The SIGNAL SF values for Spring 2022 and Autumn 2023 were consistent with the historical values for Flat Rock Creek (Figure 14), indicating that there has been no major change to stream health and habitat conditions.

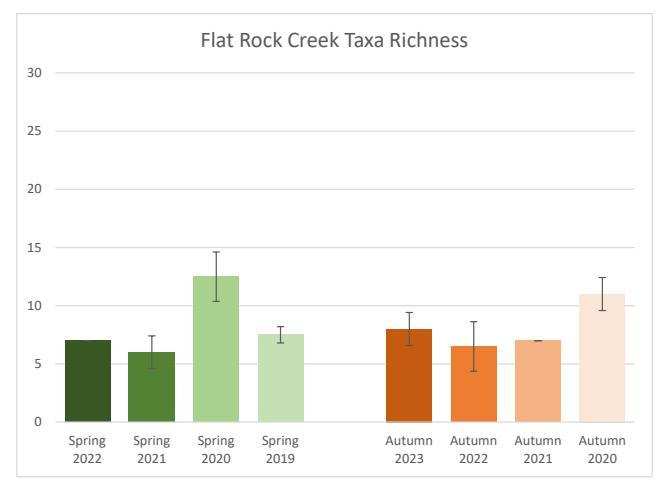
Figure 15 Flat Rock Creek SIGNAL Taxa Richness results

Taxa Richness for Spring 2022 was similar to Spring 2021 and remained notably lower than the higher than unusually high Spring 2020 result. The taxa richness for Autumn 2023 was slightly higher than Autumn 2022 (Figure 15).

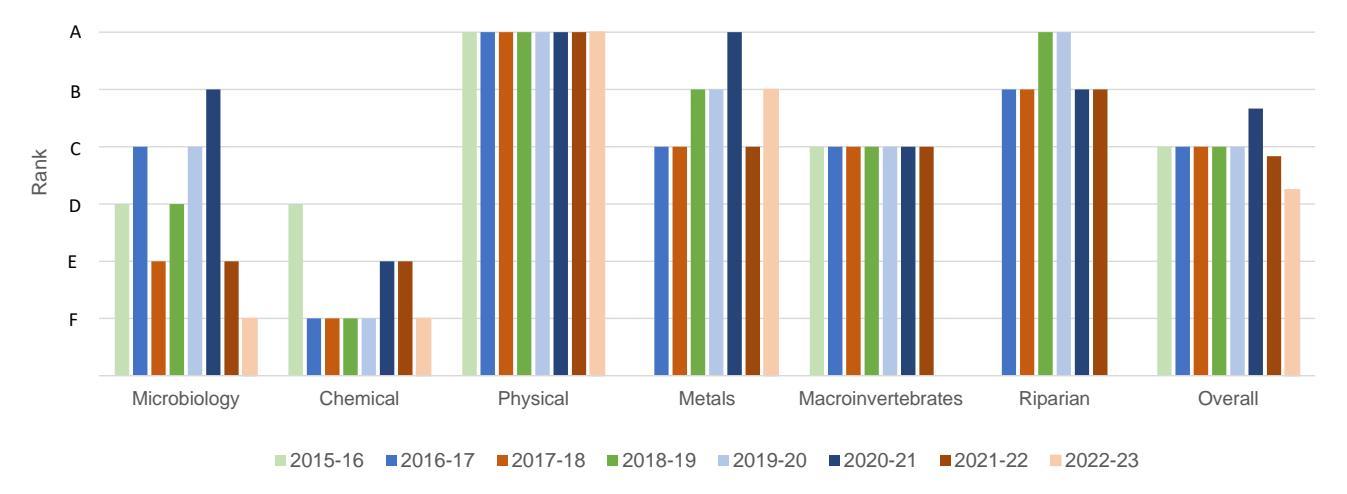
Figure 16 Summary of Flat Rock Creek at Flat Rock Gully scorecard ranking

Microbiological results were poorer than the previous sampling periods for Flat Rock Creek at Flat Rock Gully falling to a rank of F (Figure 16). Flat Rock Creek at Narremburn also showed a fall in the microbiological category from a C rank to F (Figure 17). Chemical rank fell from E to F at Flat Rock Gully, while metals increased a rank from C to B. Overall, water quality fell at both sites on Flat Rock Creek in 2022-23.

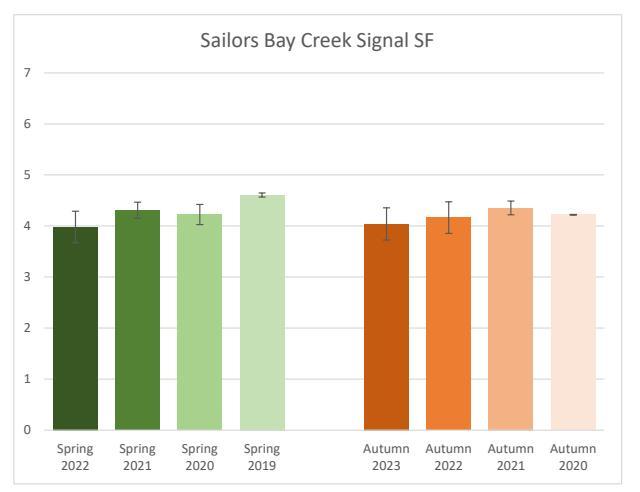
Figure 18 WCC_SB1 Sailors Bay Creek

WCC_SB1 is the sole site on Sailors Bay Creek, located midstream within the catchment. It has low flow during dry weather and the substrate consists primarily of bedrock and boulders. The sampling site is situated close to residential housing buffered with moderate levels of riparian vegetation including both native and exotic species. The presence of algae and domestic rubbish is regularly observed at this site.

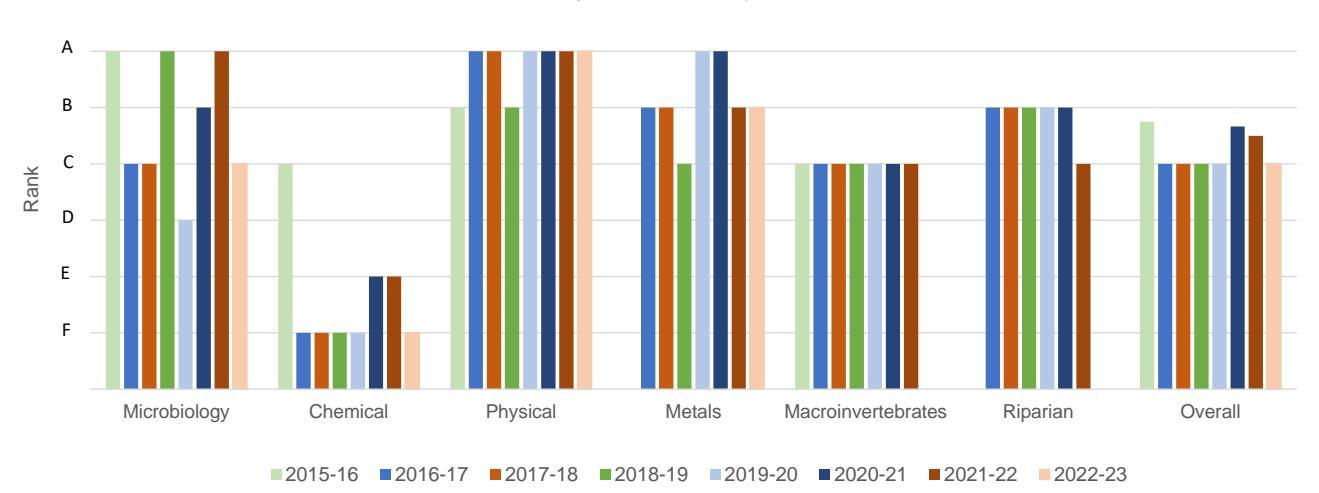
Figure 21 Summary of Sailors Bay Creek scorecard rankings

The microbiology category fell two ranks to a C in 2022-23. Combined with falls in the chemical and riparian categories, the overall scorecard ranking for Sailors Bay Creek at Keep Reserve decreased (Figure 21).

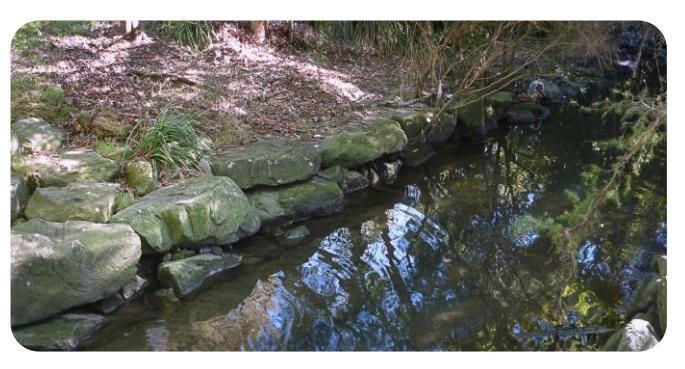
Figure 24 WCC_SC3 Scotts Creek 3 at Muston Park

WCC_SC3 is the third site on Scotts Creek, located upstream within the catchment area. It is located within Muston Park, surrounded by medium density residential houses, and features a man-made sandstone bank edge (Figure 24). Domestic rubbish has been reported at the site on several occasions and a surface scum was reported for the dry weather sampling in February 2018.

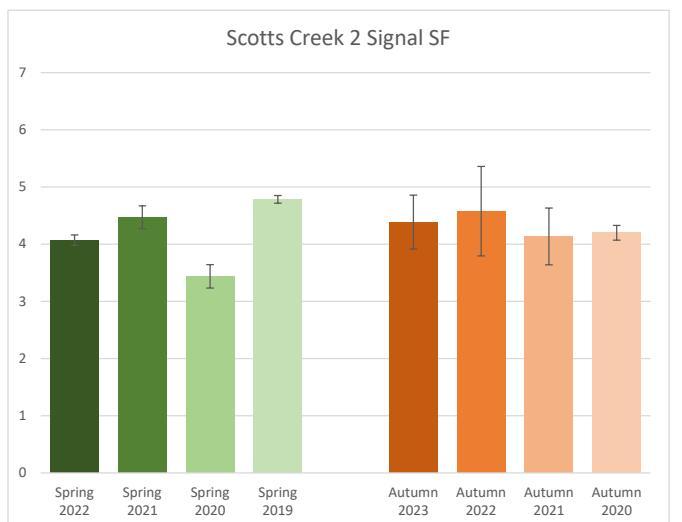
Figure 25 Scotts Creek SIGNAL SF results

The SIGNAL SF result for Spring 2022 was lower than Spring 2021 but remained higher than the low result of Spring 2020. The Autumn 2023 result was consistent with the historical results for Scotts Creek at Willis Park.

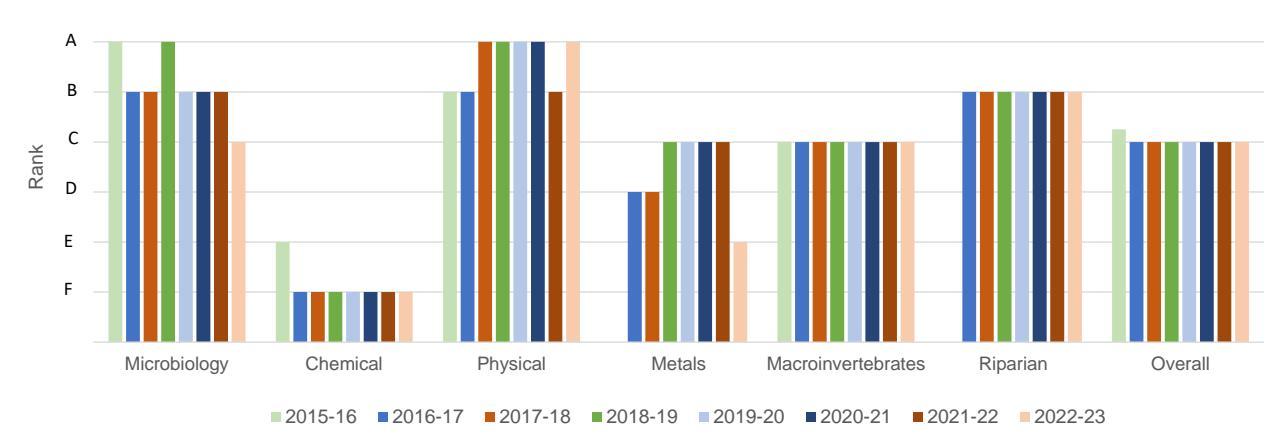
Figure 28 Summary of Scotts Creek at Willis Park scorecard rankings

Scotts Creek at the North Arm site saw an overall scorecard ranking drop slightly to below C, due to a fall in the microbiological category (Figure 27). At the Willis Park site, while the microbiological ranking fell one grade to a C, the physical category ranking increased one rank to an A, resulting in the overall scorecard ranking remaining unchanged for 2022-23 (Figure 28). At the Muston Park site the overall scorecard category increased, mainly due to improvement in microbiological category from an F to a C (Figure 29).

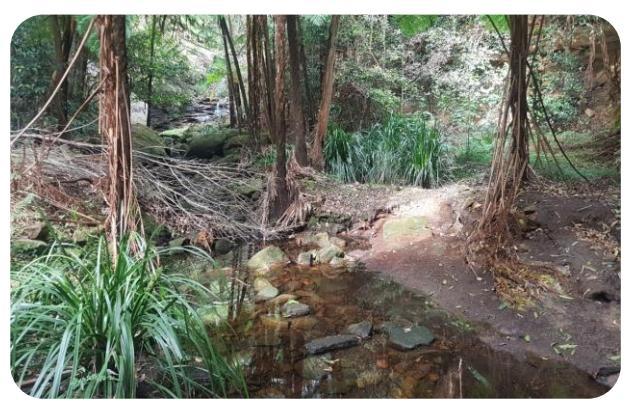
Figure 30 WCC_SGL1 Sugarloaf Creek

WCC_SGL1 is located downstream within the catchment. It is situated at the mouth of a steep catchment, below a waterfall, close to the entry into Sugarloaf Bay, Castlecrag. The substrate consists of boulders, cobbles and sand (Figure 30). Riparian vegetation consists of both native and exotic species, including heavy sections of Lantana. In Spring 2017, it was observed vegetation had been cleared along tracks, making access easier. Rubbish remains frequently sighted. Macroinvertebrates are sampled at both edge and riffle habitats.

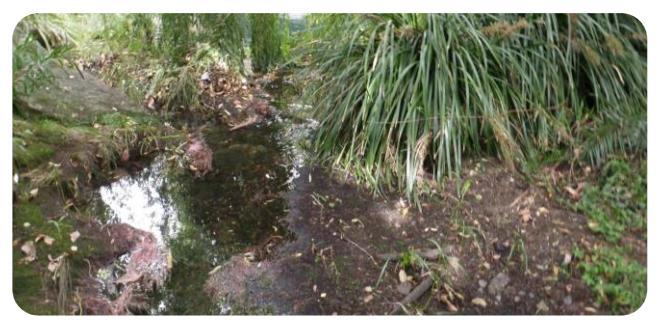
Figure 31 WCC_SGL2 Sugarloaf Creek 2 at Butt Park

WCC_SGL2 is the second water quality site on Sugarloaf Creek, located midstream within the catchment. It is located downstream of medium density residential housing, a gross pollutant trap and small waterfall (Figure 31). Domestic rubbish was recorded on several occasions. In the past, this site has experienced low flow during dry weather and emitted occasional foul odours.

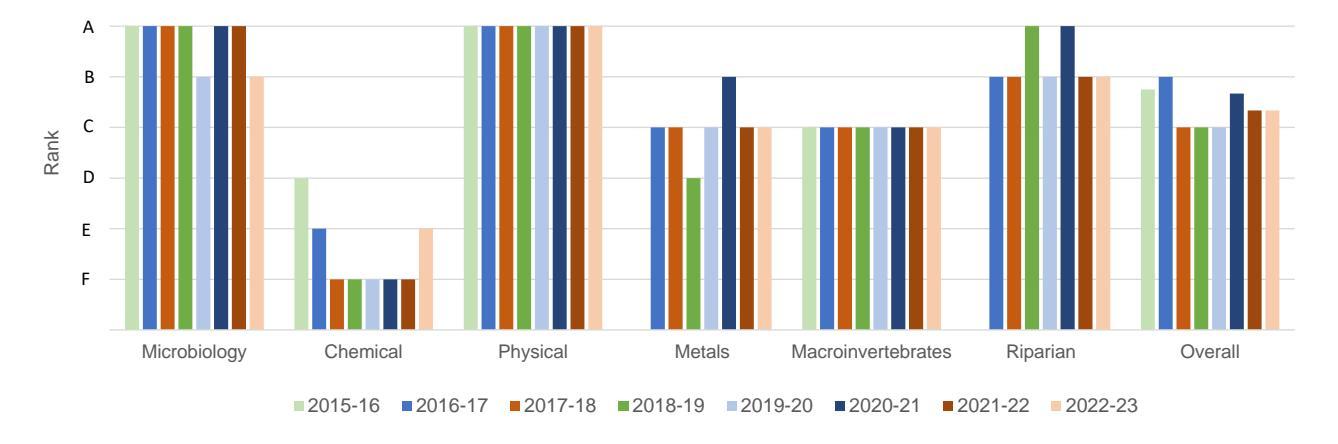
Figure 34 Summary of Sugarloaf Creek at Sunnyside scorecard rankings

At Sugarloaf Creek at Sunnyside Park, scorecard rankings for the microbiology fell one rank to a B and the chemical rank increased from an F to an E. The overall scorecard ranking remained unchanged (Figure 34). The overall scorecard ranking at Sugarloaf Creek at Butt Park also remained unchanged (Figure 35).

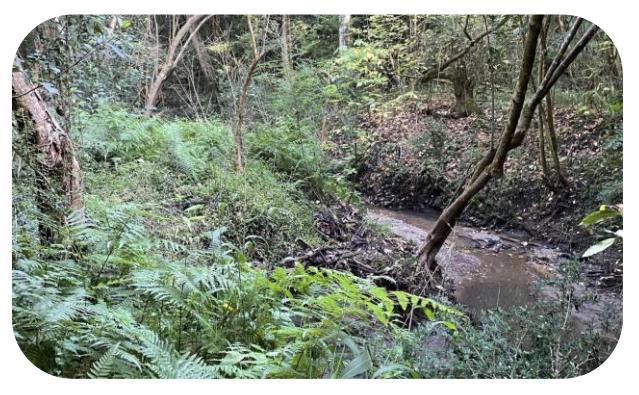
Figure 36 WCC_BG1 Blue Gum Creek

WCC_BG1 on Blue Gum Creek is the furthest site downstream of the catchment area. The sampling site is surrounded by dense riparian vegetation trailing into the creek itself. The vegetation adjacent to the sampling site is composed predominantly of exotic species, particularly *Tradescantia fluminensis.* Erosion of the creek bed has led to the substrate being composed primarily of sand and silt banks.
